Manhole Inspection Summary

Manhole # S29K__059MH

Insp Date: **1/29/09 12:45 PM**

Location Address: **700 Penn St**

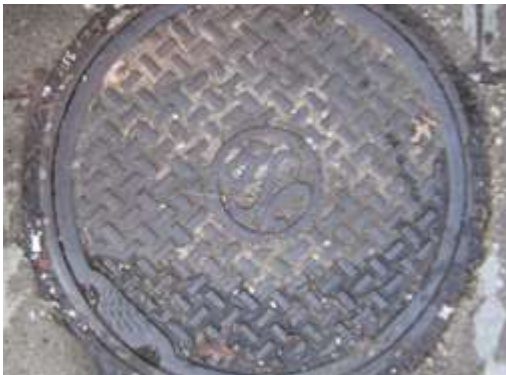
Misc

cover

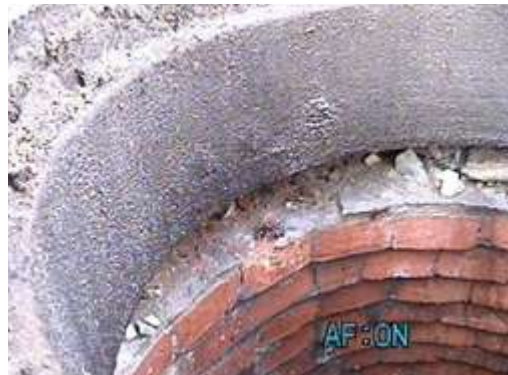
Defect 3

Chimney / Frame Adjustment

☒ Exists Material: **Brick**

Condition: ☐ Sound ☐ Cracked ☐ Root Intrusion ☐ Loose Brick ☒ **Deteriorated**

chimney deteriorated

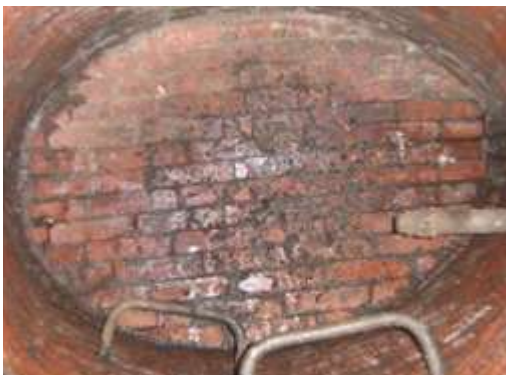
DEfect 2

Offset: **1.5** (in.)

Frame offset

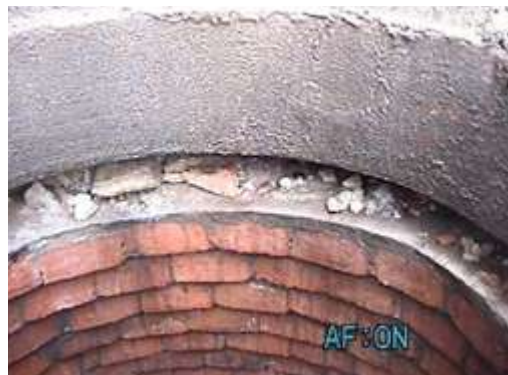
Defect 1

☒ **Leaks**

frame infiltration at cover

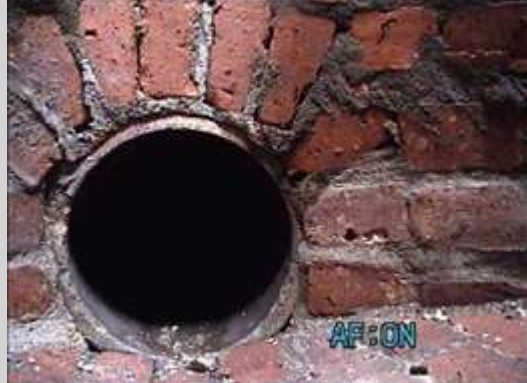
12 O'Clock Outflow

8 in. Circular Gravity Sewer
Pipe Out @ 12 O'Clock

Infiltration: **None** Pipe Seal Cond: **Sound**
